Environment and Rural Affairs Monitoring & Modelling Programme (ERAMMP)

ERAMMP Document-52: Field-Survey Handbook (Procedures) Historic Features

Version 1.1

Date: 13th February 2025

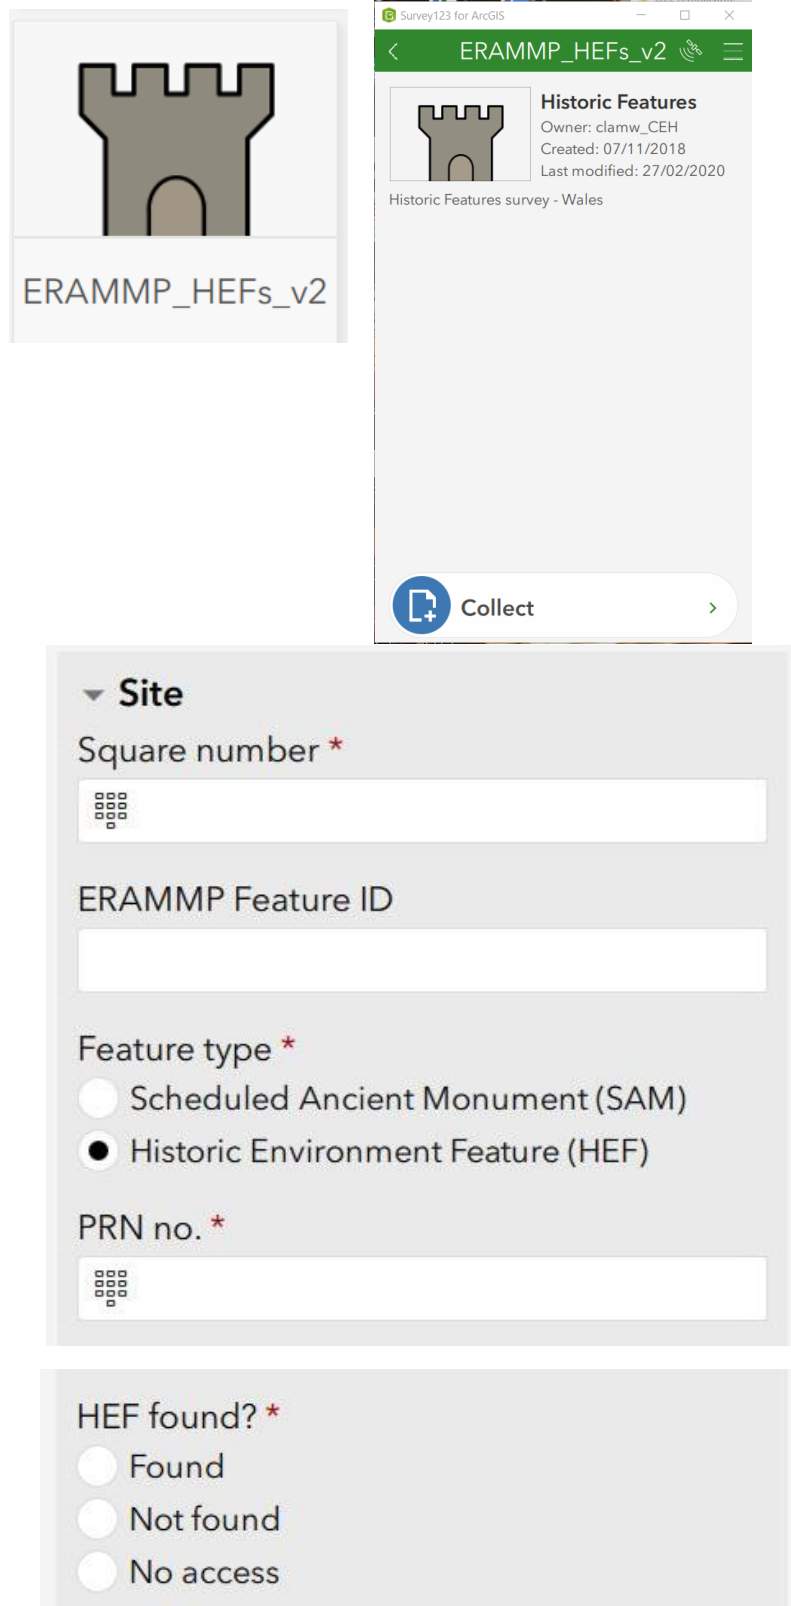
The above shows the information asked in the software. Fields with a red star are compulsory. The square number is provided in the square pack. The ERAMMP Feature ID may be provided and is formed of the square number and a number e.g. 12345_3. Please enter if available.

After selecting the type of historic feature, the SM or PRN number needs to be added. This information is SM or PRNA number) is provided on the printed hand out.

For each HA, we require the information if it was found, not found, or if there was no access to the HA. This can either be due to lack of farmer permission, or other obstacles preventing you surveying the area safely.

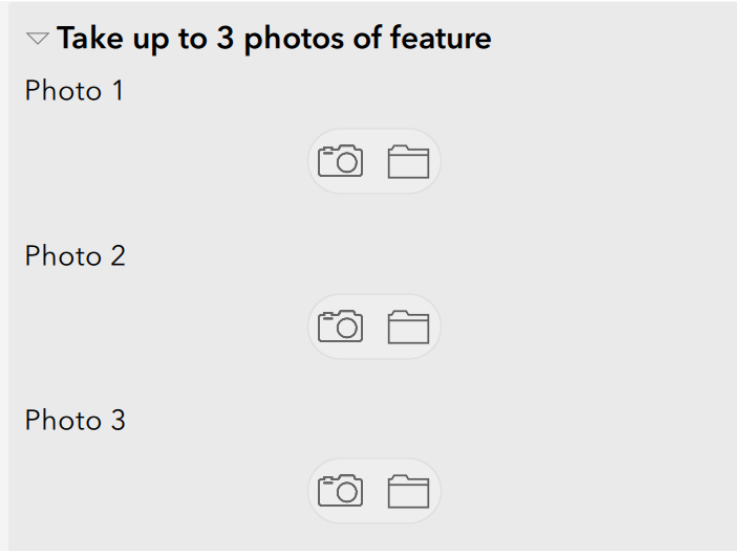
The screenshot shows a mobile application interface with a grey background. At the top, there is a dropdown menu with a downward arrow and the text "Take up to 3 photos of feature". Below this, there are three sections, each labeled "Photo 1", "Photo 2", and "Photo 3" from top to bottom. Each section contains two icons: a camera icon and a folder icon, both enclosed in rounded rectangular buttons.

Photographs are an invaluable record of condition. General shots of the site are needed along with detailed shots showing any specific condition issues that have been identified (e.g. areas of erosion, bracken infestation, etc.)

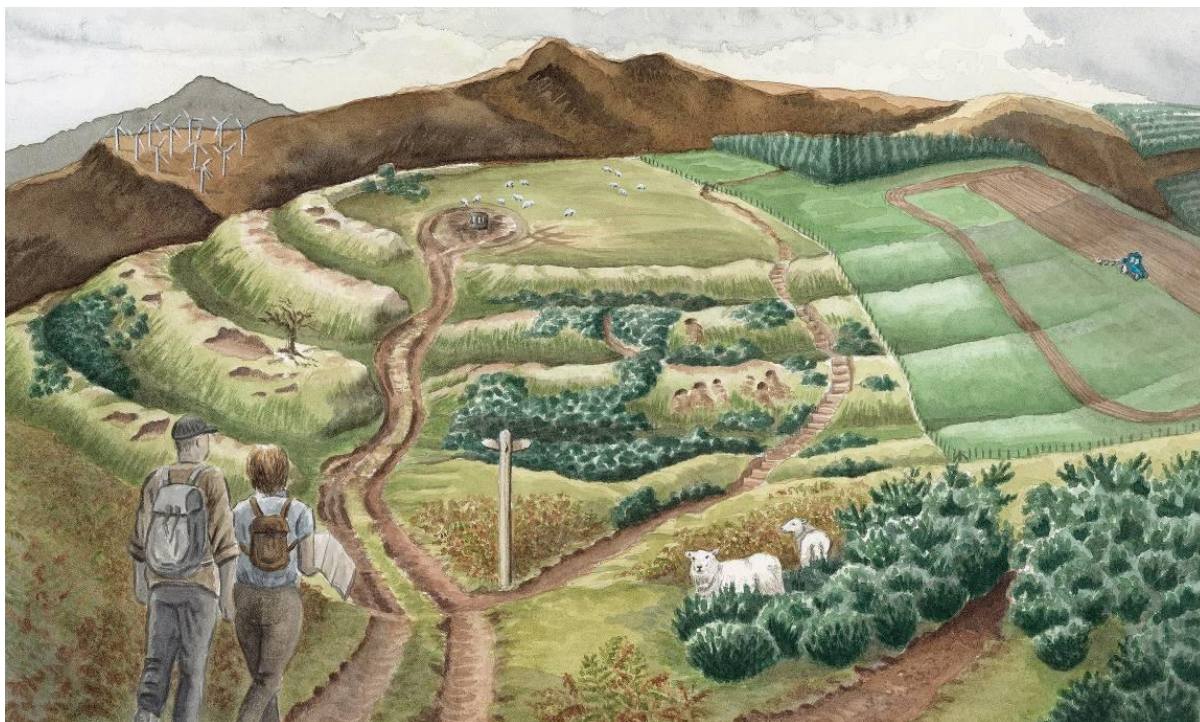
Many of the condition issues that you are likely to encounter are illustrated in this picture:

The picture illustrates:

Afforestation
Ploughing
Poaching

Inappropriate location of feeders
Tyre tracking/rutting
Stock scrapes/erosion

Invasive vegetation
Stock path wear
Footpath wear

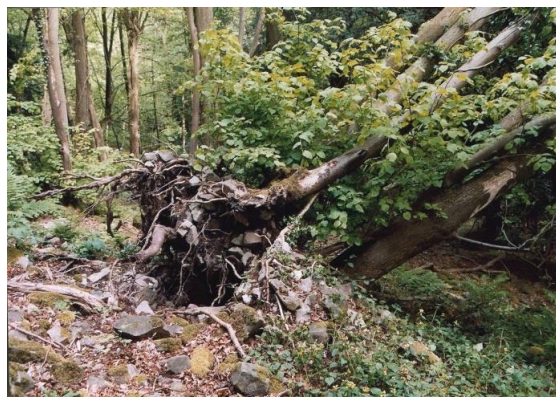
Windblow damage – resulting in the rootplate destroying archaeological deposits

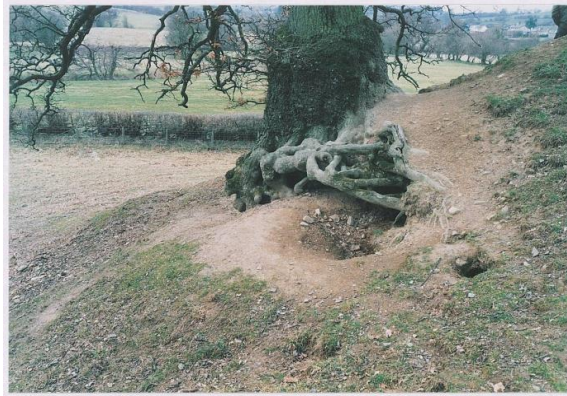
Multiple issues – tree root damage (long standing) plus badger damage & stock wear

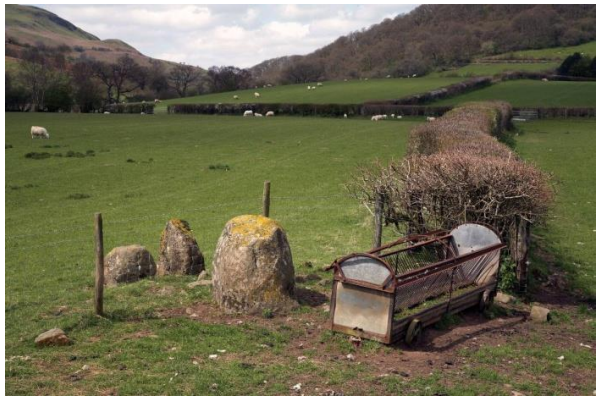
Fence through monument (long standing) & feeder to close resulting in wear and poaching

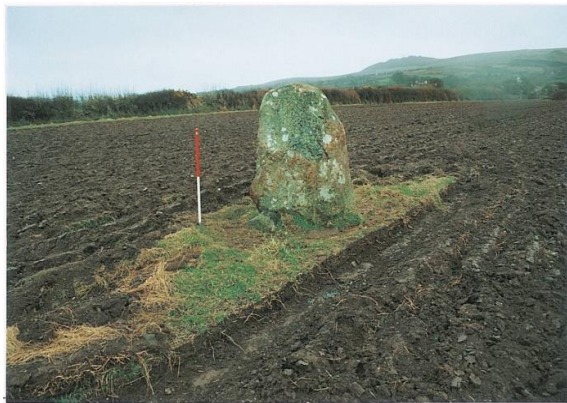
Ploughing encroachment – too close to monument

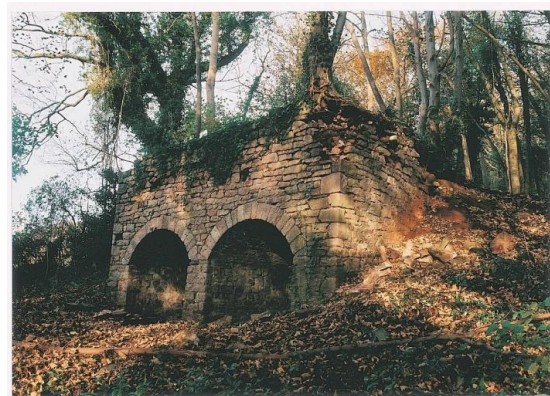
Damage to lime kiln due to vegetation growth – root system forcing out stonework – long standing issue but damage is active and ongoing

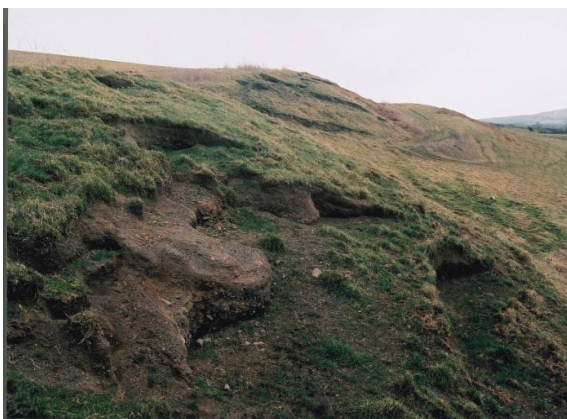
Stock erosion (persistent – although evidence of self-repair, problem is clearly longstanding and ongoing)

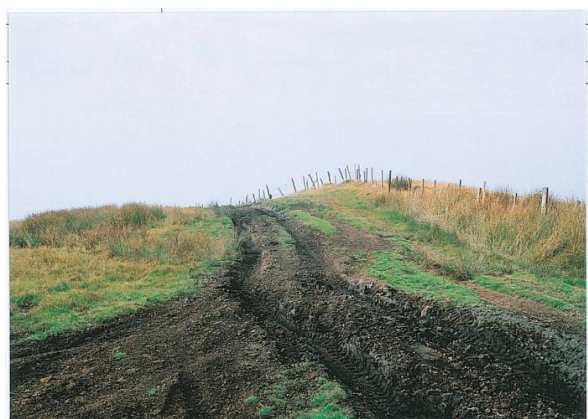
Vehicle Damage

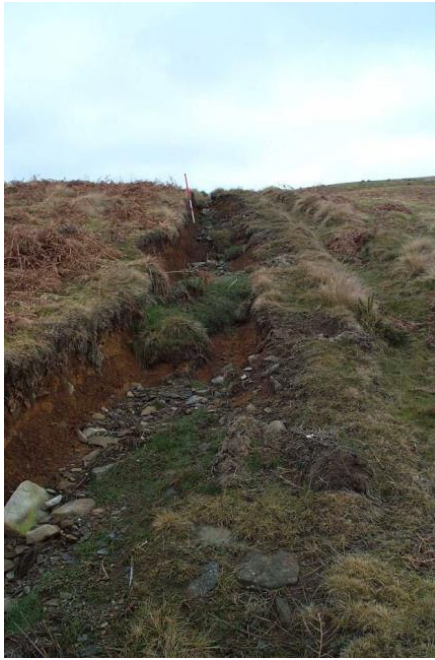
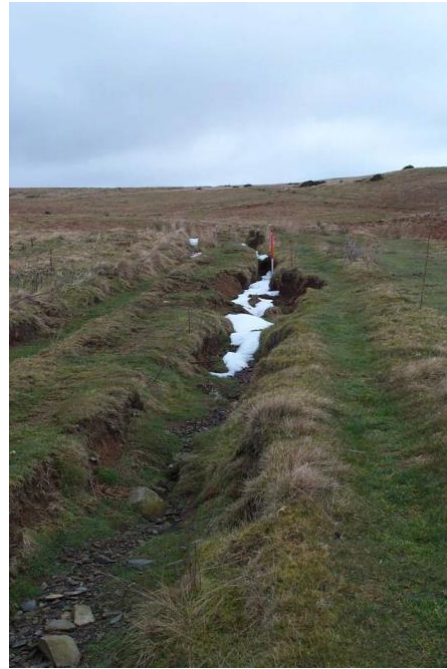
Vehicle damage – Once ruts develop they may then act as a channel for rainfall run-off resulting in significant downcutting of the channel – see above.

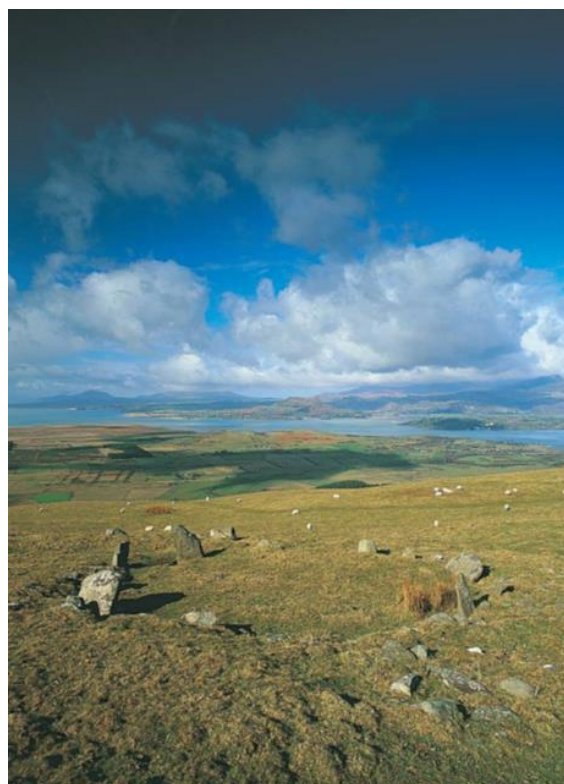
Settlement and field systems can be extensive and cover a number of hectares

Traditional perceptions of a monument may not accord with what is found on the ground particularly in upland Wales.e.g the stone circle above.

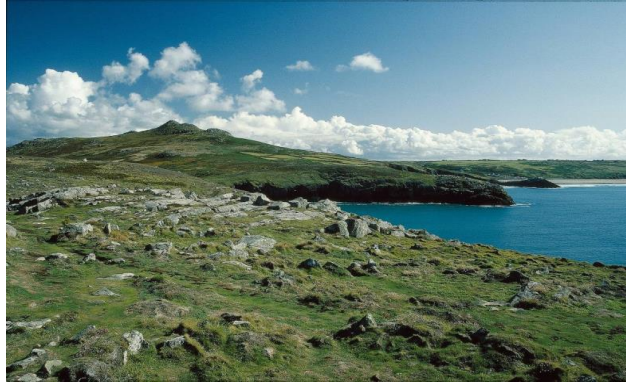
Upland monuments in particular are not always readily identifiable.
The photograph below shows a hut circle – lower right hand side of photo:

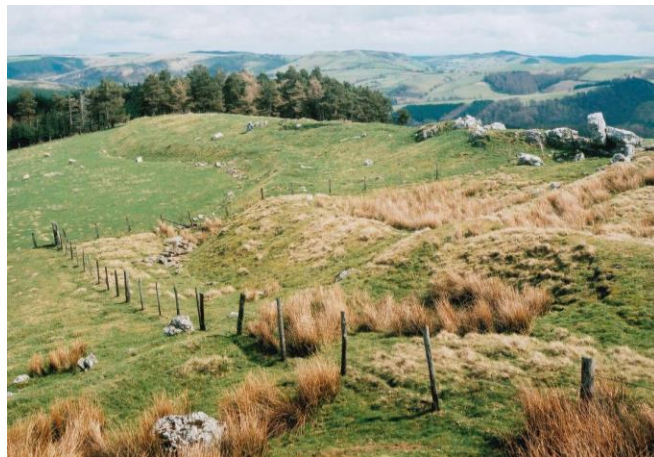
Above ground preservation of a monument will also depend on land use – see below the difference on the same monument between improved and unimproved land:
